Manhole Inspection Summary

Manhole # S31SS_020MH

Insp Date: **5/9/07 11:53 AM**

Location Address: **2701 CRESTMONT AVE**

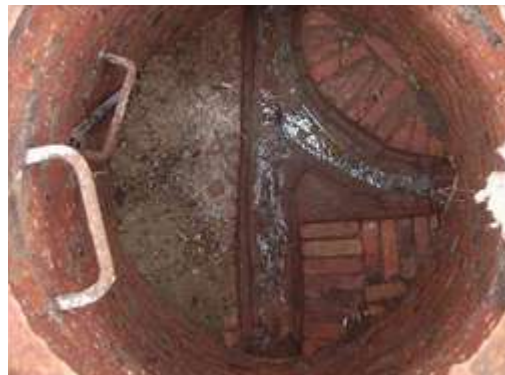
Top View

Corroded steps. Evidence of surcharge - Bench debris.

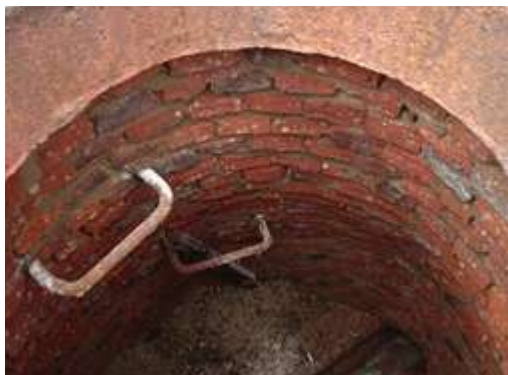
Defect

Frame leaks. Adjustment and Corbel deterioration and infiltration. Barrel infiltration - other side.

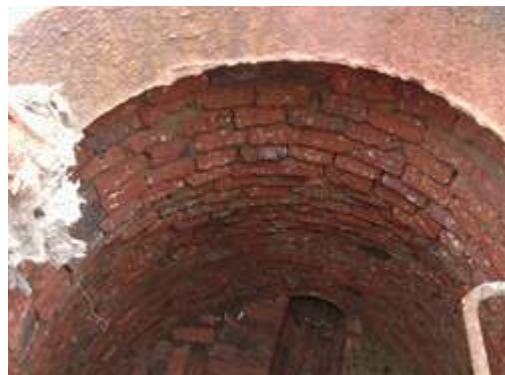
Defect

Frame leaks. Adjustment and Corbel deterioration and infiltration. Barrel infiltration.

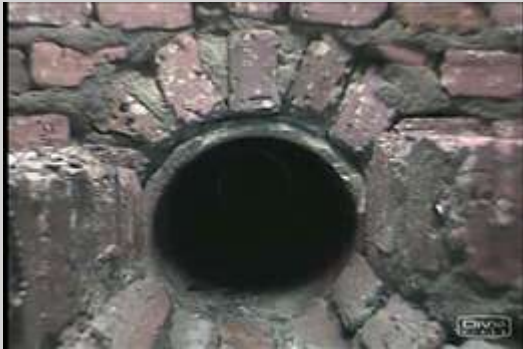
8 in. Circular Gravity Sewer Pipe Out @ 12 O'Clock

Barrel deterioration and infiltration. Channel deterioration.
